11FTM18

AGMA Technical Paper

Longitudinal Tooth Contact Pattern Shift

John B. Amendola, John B. Amendola III, and Dereck Yatzook, Artec Machine Systems

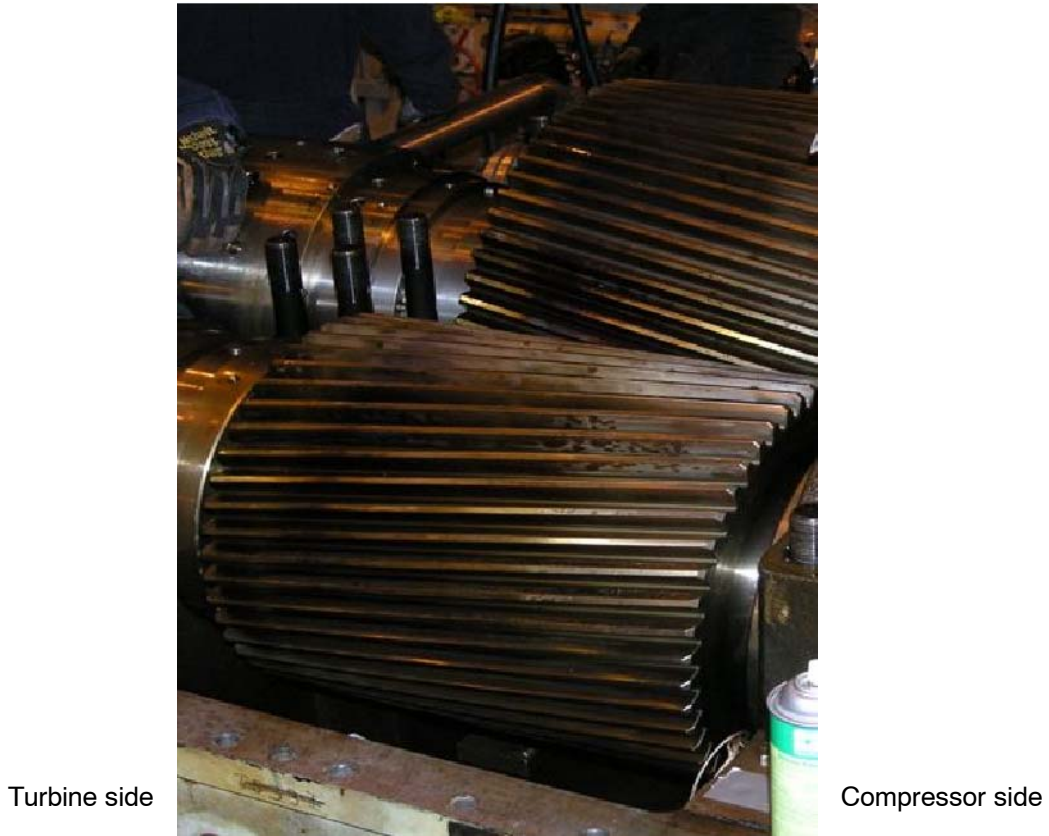
Figure 5. Varnish deposits on gear teeth

After 105,000 hours the gearset showed no signs of tooth surface distress; i.e., scuffing, micropitting and virtually no signs of pitting (a few pits were found on the dedendum of the pinion). Varnishing (on both pinion and wheel) was noted to be heaviest in the flank section with the deepest lead correction. However under observation it was readily noted that the “dynamic” load clearly favored the turbine end, little or no load appeared to have been transmitted over the first ~ 150 mm of tooth face nearest the compressor end.

Considering the successful length of service in the noted example it can be determined with certainty that the gearset was furnished with an optimized lead and at the outset of service the unit operated with uniform contact across the entire full face width of the toothing. As service time was accumulated a segment of the tooth flank increased in temperature and reached the tempering temperature range. This most likely was the result of accumulated varnish staining of the gear teeth. Transformation occurred slowly at first and then increased at a faster rate reducing flank contact over time. The appearance of significant varnishing of the gear teeth was the cause of this rise in tooth temperature.

- Varnish is an insulator on the gear teeth thereby reducing the efficiency of the lube oil to cool the gear teeth. As the varnish builds up a worsening condition develops. As a result, the gear teeth will get hotter thereby encouraging tempering of the gear teeth in that regime of the flank.
- Varnishing increases the frictional affects of the compressed lube oil and air as it travels longitudinally across the flank thereby adding additional heat to the tooth flanks.

1. Provide sufficient lubrication for mesh cooling as this is essential to avoid the tempering effect.
2. Utilize lube oil with a high resistance against oxidizing under load and if possible change routinely; i.e., every 25,000 hours.
3. Install improved filtration systems that reduce or even eliminate varnish deposits. Electrostatic filtration is reputedly a method of treating the problem. With oils of relatively low viscosities a considerable amount of the submicron resinous material can be stripped out of the oil using charged-particle separators. Also known as electrostatic filters or precipitators, these units separate carbon and oxidized particles by field-induced electromechanical forces (charges) on polar carbon and oxide insolubles. The charged

7. Encourage periodic shutdown inspections allowing the gear teeth to be cleaned of any varnish deposits according to the manufacturer's recommendations.

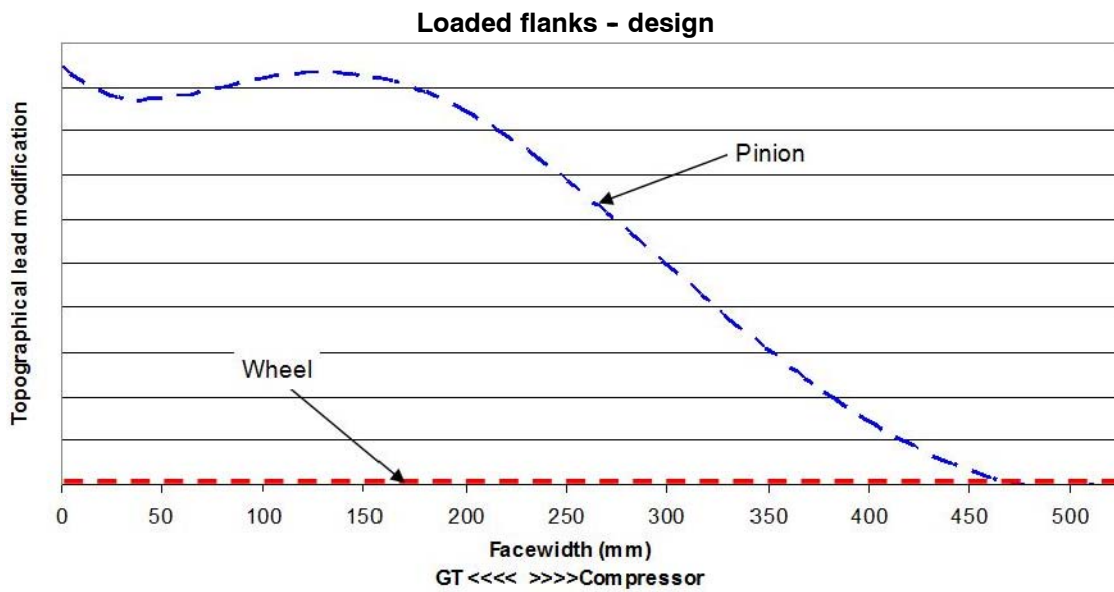
Figure 6. Original tothing modification plan
(Ordinate values intentionally omitted for proprietary reasons)

The old pinion and gear which were taken out of service were placed on a lead and profile checking machine to determine the as found lead and profile measurements. Figure 6 describes the original corrective values as made on the gearset loaded tooth flanks prior to operation. Figure 7 describes the as found loaded tooth flank measured values. Comparison of these figures demonstrates tooth flank expansion which shifted the original no load static contact pattern and provided obvious evidence of permanent deformation of the gear teeth.

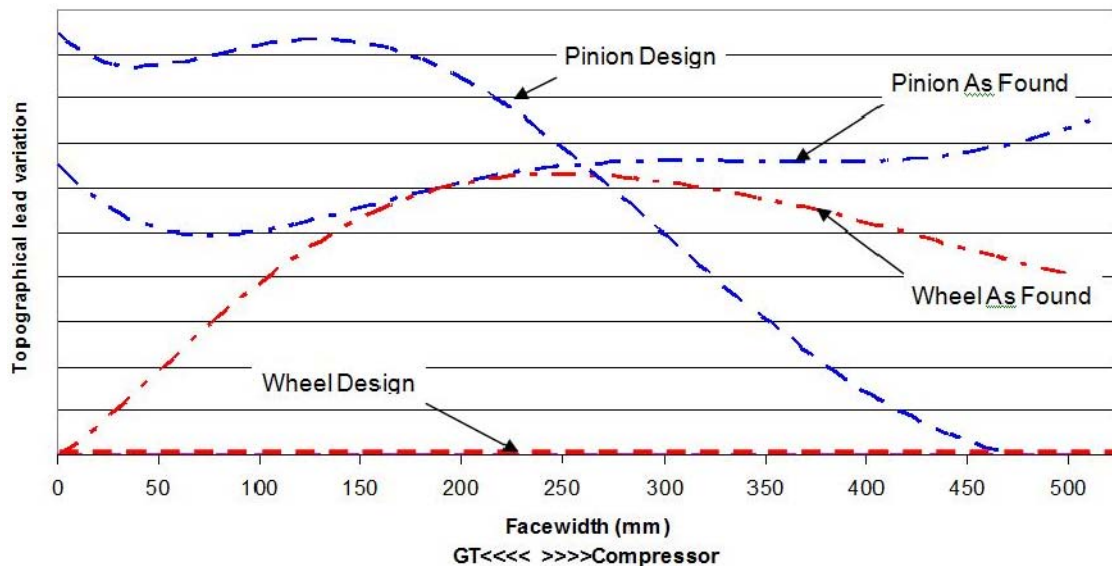
Figure 7. Loaded flank - design and as found
(Ordinate values intentionally omitted for proprietary reasons)

In the case study highly localized temperatures had reached levels that caused a metallurgical transformation wherein entrained austenite was transformed to martensite. This transformation resulted in an expansion of the case material thereby affecting the tooth thickness which resulted in a contact pattern change on both the loaded and non-loaded flanks. The mechanism of expansion is due to the density difference between austenite and martensite. As noted from Figure 9 this expansion does not occur in a uniform manner since the temperature rise from the meshing action is asymmetrical over the tooth length.

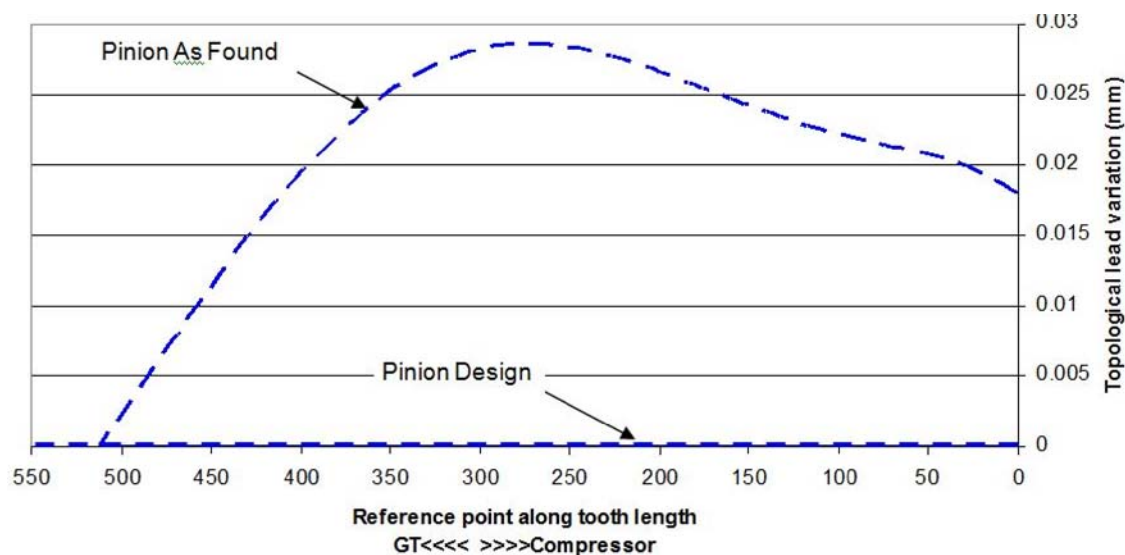
Permanent deformation was also evident on the non-loaded tooth flanks (back side). Figure 8 and Figure 9 provide a graphical comparison of each rotor non-loaded tooth flanks showing the amount of change that took place for both the pinion and wheel.

Figure 8. Pinion unloaded flank - design versus as found

The expansion is remarkable insofar as it has a magnitude nearly 75% of the amount of the design lead modification.

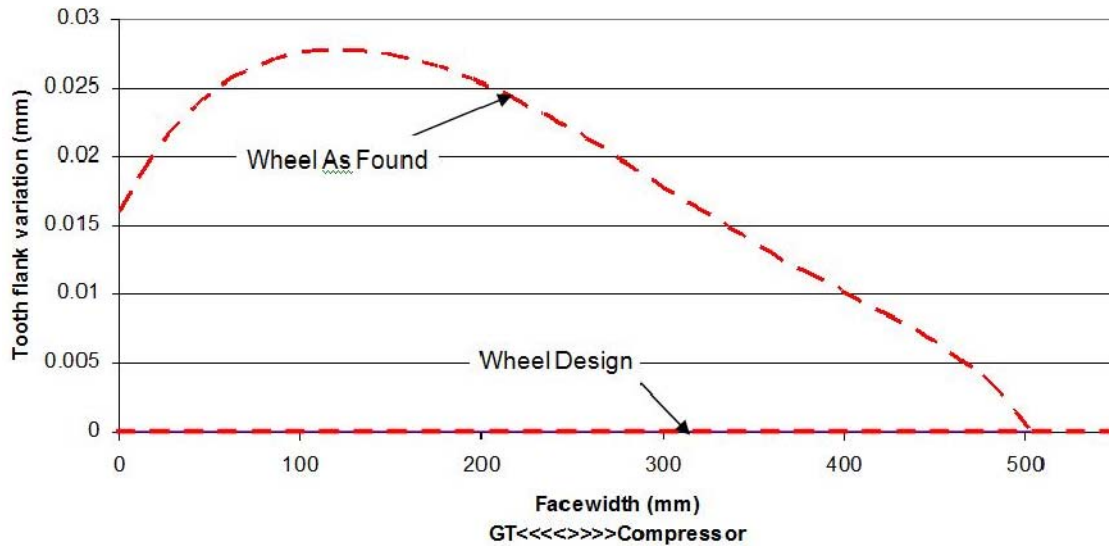
Figure 9. Wheel unloaded flank - design versus actual
