The Effect of Material Defects on Gear Performance—A Case Study

Raymond J. Drago, P.E. and Alejandro Font Filax, Ph.D.

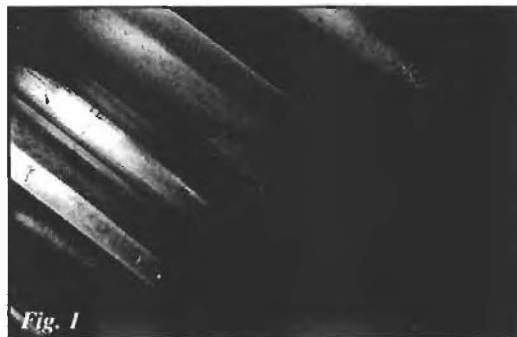
Fig. 1—Distress observed on ball mill pinion during 1994 visual evaluation.

performed without significant incident until some pitting was discovered during a visual examination conducted late in 1994. At that time, we noted only very minor surface distress, as Figures 1 and 2 show. The distress was located at about the middle of the face width and had been slightly ground out at the time of my November 1994 visit.

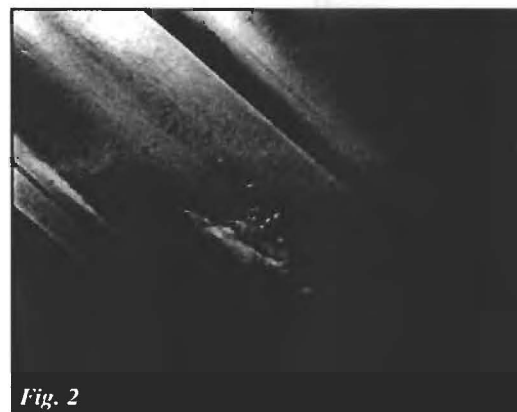
Fig. 2—Close view of distress observed on ball mill pinion during 1994 inspection.

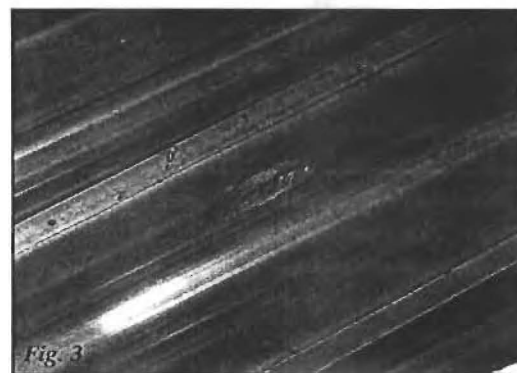
Fig. 3—Currently installed ball mill #2 pinion showing region (near mid-ce) which has been ground out to remove pitting and surface cracks and then restarted.

The failed pinion was replaced and the mill restarted. During a visual inspection conducted in early 1999, the new replacement pinion was found to be exhibiting pitting very similar in both extent and location to the pitting in the original pinion. This pitting was hand dressed out and was found to have not progressed significantly during a visual inspection, which was conducted during April 1999, as Figure 3 shows.

During an inspection in April 1999, we did not observe any cracks on this pinion (we were unable to dye check it). However, the pinion was reported to have some cracks in the pitted region which were discovered during a previous dye check inspection. The cracks were ground out and the pinion was returned to service. At the time of our inspection, it appeared that only minor progression of the pitting was occurring.

If this pitting is the result of material anomalies as was the fractured mill pinion described below, dressing the pitted area will lower the stress level in the region where the inclusions appear to be prevalent, thus reducing the possibility that they will cause a crack initiation and progression mechanism similar to that which led to the failure.

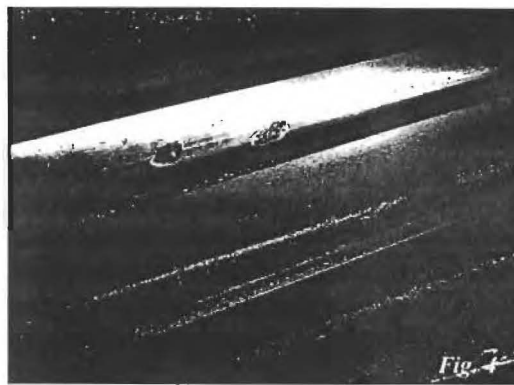
As noted above, there are two identical mill gear systems on line at this site. The second mill was running at the time of our visit and we were unable to shut it down for a good look at the teeth. We examined the teeth through the inspection port with the aid of a strobe, which allowed the pinion and gear rotation to be "stopped" artificially. As Figure 4 shows, this pinion exhibited moderate surface distress in the form of pitting.

We could not detect any cracks on the surface of this pinion; however, it would be almost impossible to do so under the conditions of this inspection. The regions of pitting observed were similar in size to those observed on the first (failed) mill pinion, but they were in a somewhat different location along the face width. In the profile direction, the pitting was located near the pitch line on both mill pinions.

Fig. 4—Pitting distress on second mill pinion teeth.

The distress is located about 2/3 of the face width from the motor end of the face width. While Figure 4 shows typical distress, it is important to note that not all pinion teeth exhibit this distress. Figure 5 shows another group of pinion teeth on

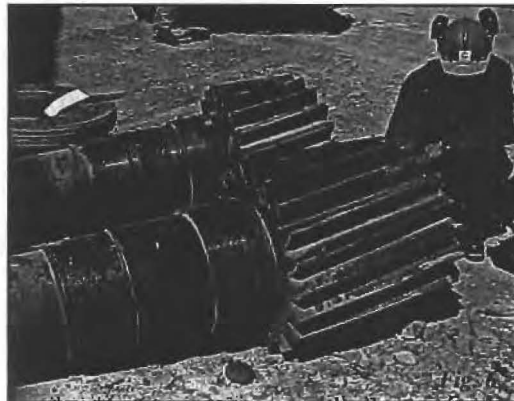
Fig. 6—Failed pinion removed from #2 ball mill in August 1998.

The pinion, which failed in August 1998, was available for our visual examination; however, as Figure 6 shows, it was quite rusted. Still, our visual evaluation provided valuable clues regarding the cause of the failure.

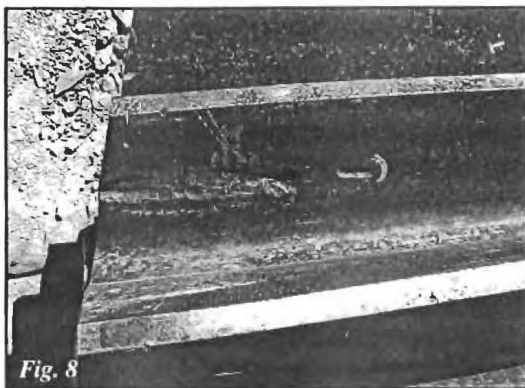
Fig. 8—Pitting observed on fractured pinion. Note the ground out condition of the pitted area and the lack of new progression.

It was reported that this pinion had been run in both directions and that the contact apparent on the tooth flanks confirms this. It was also reported to me that this pinion had been running in one direction only for "...many years..." The pitting observed was reported to have occurred generally at four locations, positioned about 90 degrees apart. The pitting which I observed on this pinion (Figure 8) was not sufficient, of and by itself, to account for this massive crack propagation failure. Note also that this level of pitting is not very different from that which I observed on this same pinion when I last visually evaluated it during my November 1994 visit (see Figures 6 and 7 above). Close examination of Figure 8 clearly shows that there was no real progression of the pitting distress and that the fracture does not appear to originate in the pitted region.

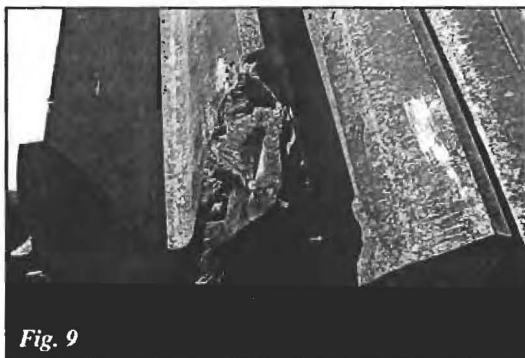
9—Fractured tooth surface, suggestive of a subsurface flaw.

The surface characteristics of the failure, as shown in Figure 9, suggest the presence of a subsurface defect, which initiated the crack that propagated to failure. Despite the rusted nature of the fracture face, it is still relatively smooth in appearance. It is clear that multiple crack branches have propagated in the region of the fracture. This topography is suggestive of a fatigue crack propagation mechanism. Scanning electron microscopy of this region showed crack growth rates of 10^{-4} mm/cycle, that is, 80 mm in 3 days of operation.

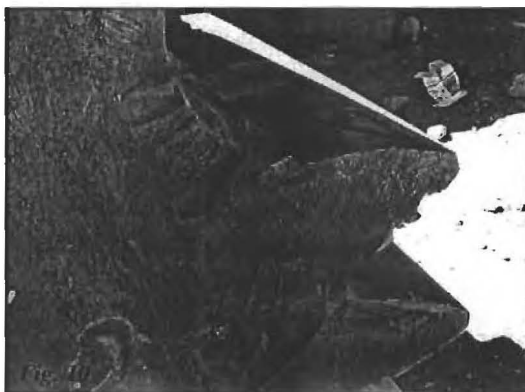
Fig. 10—Cracks progressed from the tooth roots.

Based on the view of the fracture face shown in Figure 10, it appears that the original failure had multiple origins and that it spread from the tooth root area down into the shaft section.

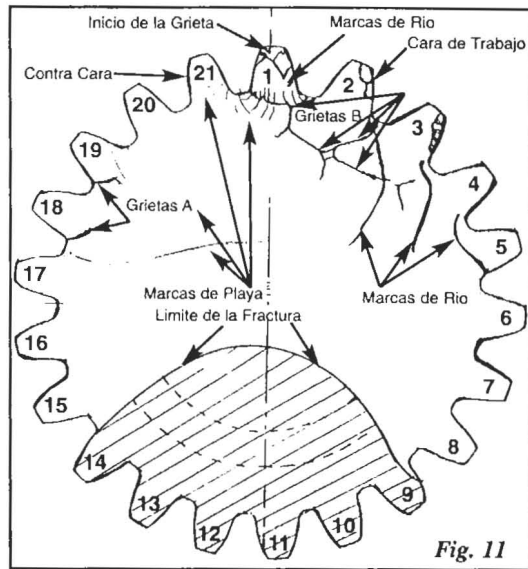
The fracture failure of this pinion shaft is an extreme example of the highly deleterious effects of material anomalies on the load capacity, reliability and life expectancy of large gears. The specific mode of failure experienced was via initiation of cracks near the top of one tooth with propagation occurring across approximately 75% to 85% of the shaft cross section, as Figures 11 and 12 clearly indicate. The cross hatched areas in these figures show the region which was cut to expose the fracture faces while the unhatched regions show the region over which the cracks progressed. Note especially the origin of the failure in the tooth top at the top of both figures and the extensive, branched crack network below the origin.

Fig. 11—Pinion fracture face. Mating surface shown in Figure 12.

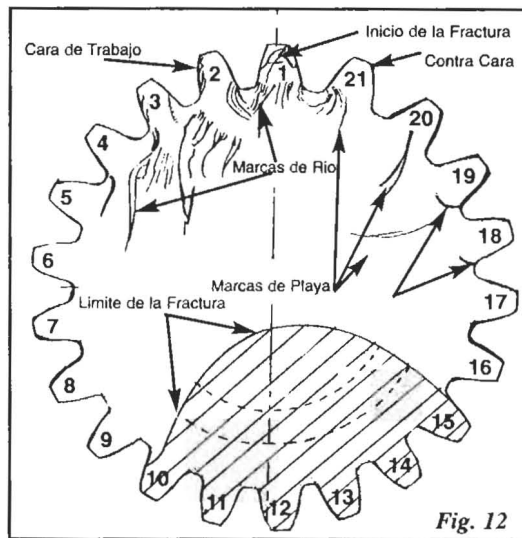
Fig. 12

Fig. 12—Pinion fracture face. Mating surface shown in Figure 11.

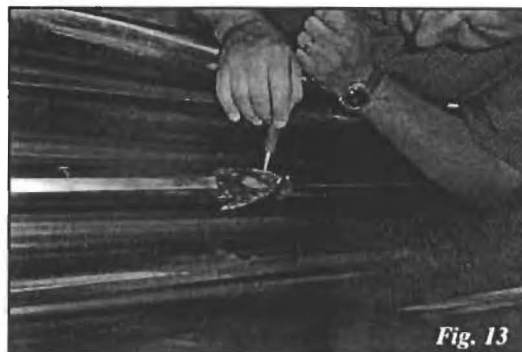
Fig. 13

The relatively good condition of the teeth over most of the face width combined with the large piece which was fractured away from one tooth near the middle of the face from just below the pitch diameter of the tooth tip very strongly suggests a localized anomaly. Pitting failures due to overloading or overall material insufficiency (e.g., low hardness, etc.) will manifest themselves relatively uniformly on all or most teeth while pitting failures due to misalignment-induced overloading

Fig. 13—Fractured pinion after removal. Note the large piece fractured from one tooth.

will occur in a localized region of the face width, biased to the more highly loaded end but also uniformly dispersed on most or all teeth. The surface failures observed on this pinion were highly localized, as Figure 13 shows.

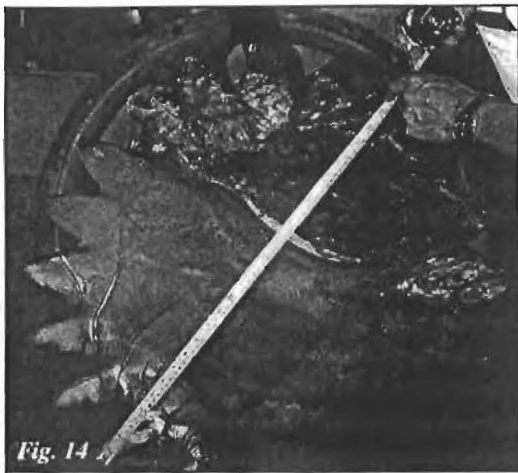
The pinion was cut through the remaining shaft section to render the fracture faces visible. Figures 14 and 15 show the fracture faces after shaft sectioning. In Figure 14, the darker region in the upper right of the photograph is the section that was cut through to reveal the fracture face, which

Fig. 14—Pinion fracture face corresponding to Figure 12.

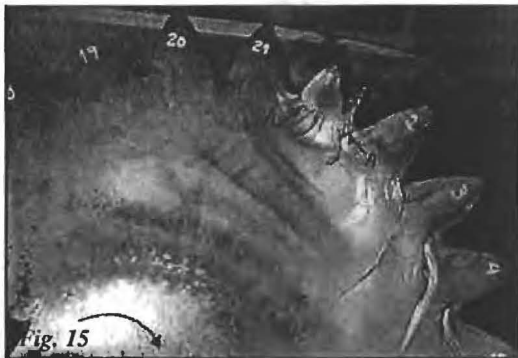
Fig. 15—Pinion fracture face corresponding to Figure 11.

is the smoother surface at the lower left of this photograph. It is clear from these figures that the origin of the crack network is in the tooth region identified by the arrows shown in Figure 15.

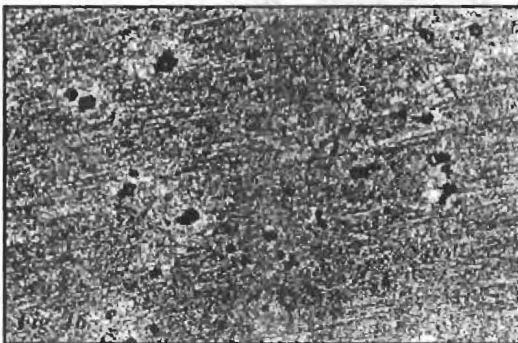
Fig. 16—Inclusions that were found in the fracture origin region.

Once polished and etched, these sections revealed the presence of large concentrations of inclusions, as Figure 16 shows. These inclusions were widely distributed in the region where the cracks originated. Such inclusions are, of course, impurities in the basic steel forging. The effect of inclusions on the capacity of the gear depends very much on their location.

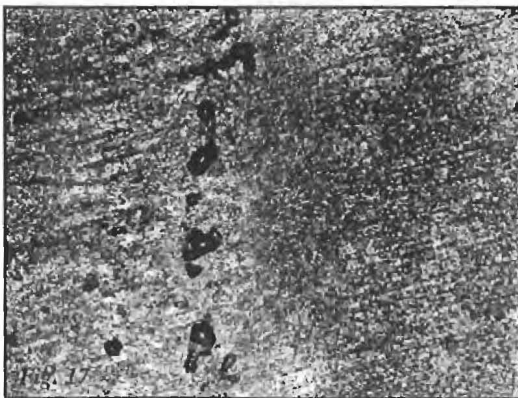
Fig. 17—Inclusions clustered in a longitudinal pattern.

Of even greater significance is the situation which occurs when inclusions occur in clusters, as Figure 17 shows. These clustered inclusions form a very large stress concentration and can adversely affect both the surface load capacity and bending fatigue strength of the teeth. When clustered, the negative effect of an inclusion is magnified many times over.

It was a group of inclusions, such as the ones shown in Figure 17, which caused the failure of this pinion. Specifically, the clustered inclusions were located below the surface but within the high stress region. As Figure 18 shows, the fracture passed through the pitted region. The pitted
