# RE-COUPLING FOR RELIABILITY

**STEVE ROGAN, ARTEC MACHINE SYSTEMS, USA, PRESENTS A CASE STUDY WHERE A GEAR TOOTH COUPLING WAS REPLACED WITH A FLEXIBLE DISC COUPLING.**

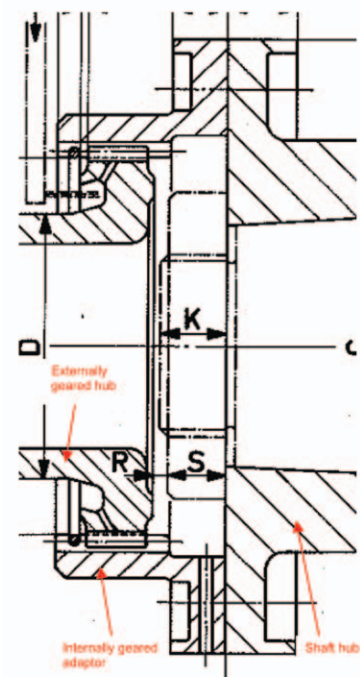
Figure 1. Hub schematic.

The original coupling design was a marine style gear tooth coupling with both internally geared rings bolted to the coupling hubs, which are dual keyed and shrunk fit onto straight shafts (Figure 1). The marine style design, which was implemented for ease of emergency replacement, enabling all of the geared components to be removed without disturbing the coupling hubs, also enabled the design and installation of a drop in replacement flexible disk type coupling.

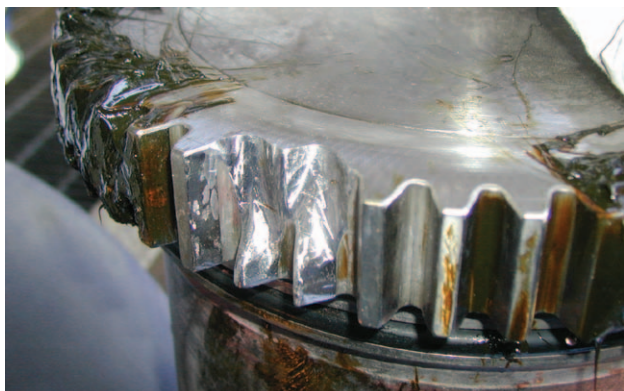
Figure 2. Refurbished gear tooth spacer ready to re-install as a temporary solution.

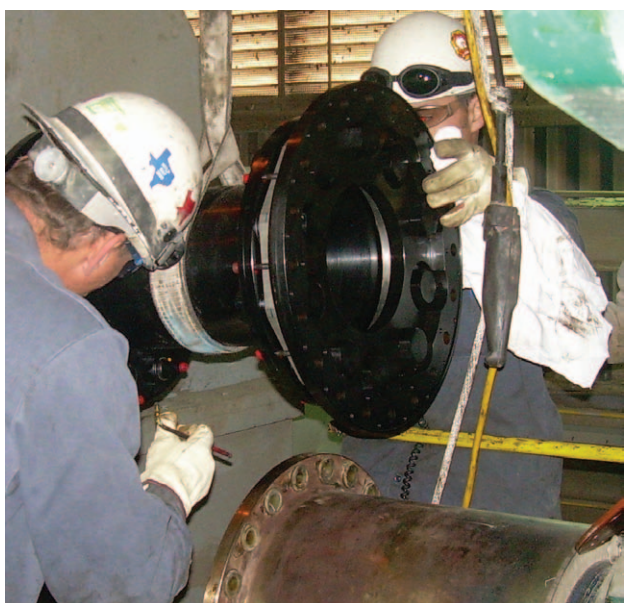
Figure 3. Installation of flexible disc coupling.

Important factors influencing the consideration of a flexible disc coupling for this application were the dry operation with no sliding surfaces, requiring no periodic maintenance, and the ability to easily install the equipment without altering the physical mounting of the coupling spacer to the coupling hubs.

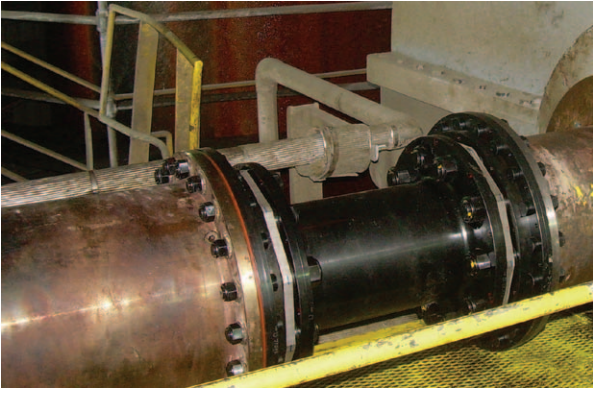
Figure 4. Flexible disc coupling installed.
