# Direct observations of a micropit in an elastohydrodynamic contact

A.V. Olver\*, L.K. Tiew, S. Medina, J.W. Choo

*Tribology Section, Department of Mechanical Engineering, Imperial College London, Exhibition Road, London SW7 2AZ, UK*

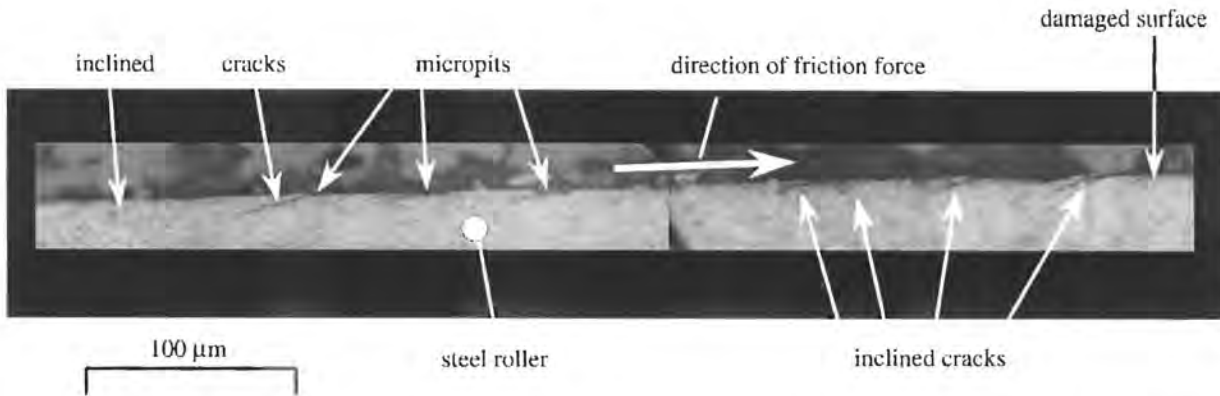
Fig. 1. Cross section of typical micropitted surface in hard steel, showing relationship of crack inclination to direction of friction force.

In the early stages of growth, the cracks which give rise to pitting or micropitting are usually shallowly inclined to the surface as shown in Fig. 1. The direction of this inclination is determined only by the direction of the applied traction and is not affected by that of the motion of the contact itself. However, *propagation* of these initial cracks has been found to require that the area of contact moves across the cracked surface from the mouth of the crack toward its tip, a situation encountered on the “follower” of discs in tractive rolling – or in the dedendum of gears. Nakajima [6] confirmed this by actually reversing rolling and sliding directions after cracks had been initiated.

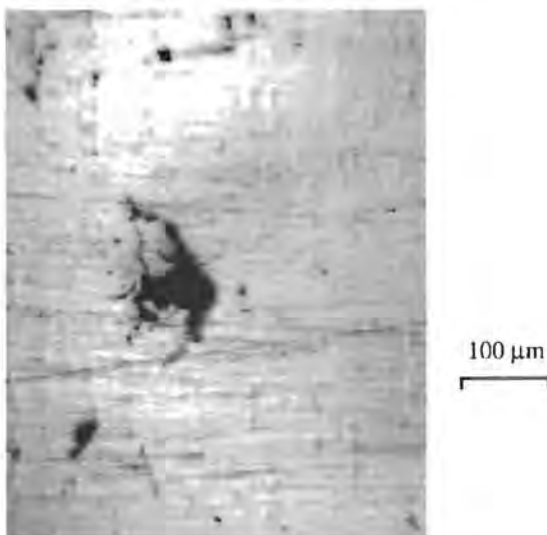
Fig. 2. Optical micrograph of isolated micropit used for the present study.

In order to improve its optical properties, the test roller was lightly polished with 1200 grit silicon carbide paper followed by 3  $\mu\text{m}$  and then 1  $\mu\text{m}$  diamond slurry. This had the effect of reducing the surface roughness to  $R_a = 327.6$  nm. A single micropit on the test roller was selected for further study and is shown in Fig. 2. The topography of the surface adjacent to the cracked region was measured using an interference microscope (Wyko) and is shown in Fig. 3. The micropit had a typical v-shape, about 100  $\mu\text{m}$  in size and

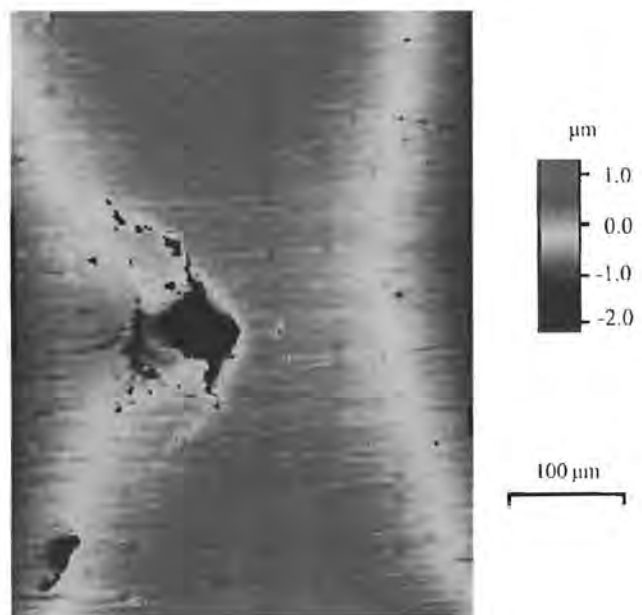
Fig. 3. Surface topography of test micropit (Wyko).

had a surface crack leading away in the rolling direction for a distance of around 190  $\mu\text{m}$ .

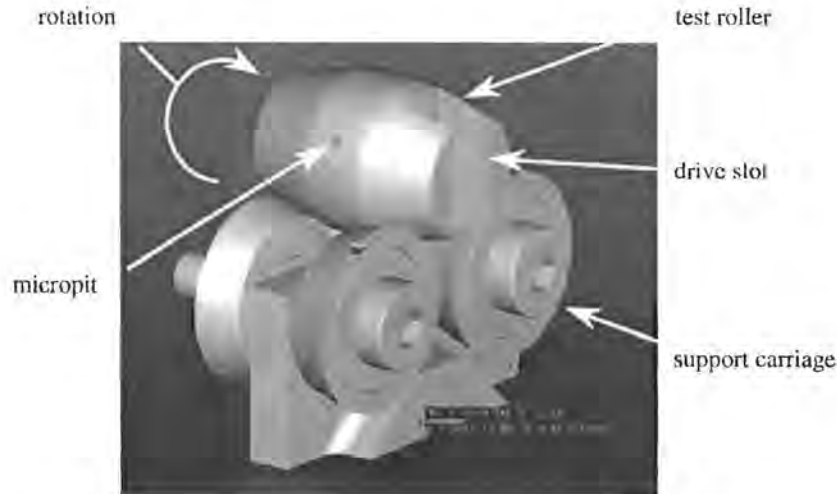
Fig. 4. Specimen carriage used to support micropitted test roller in optical rig.

The test roller was then mounted on a special carriage (Fig. 4) enabling it to be pressed against the flat glass disc of an optical rig. The arrangement of the rig is shown in Fig. 5. All tests were carried out at a normal load of 20 N giving a Hertz pressure of 334 MPa and an elliptical area of contact of 566  $\mu\text{m} \times 202$   $\mu\text{m}$ . The direction of rotation was such that the narrow end of the pit entered the contact first as it had previously done in the disc machine. The bulk temperature was controlled to  $40 \pm 1$  °C using electric heaters.

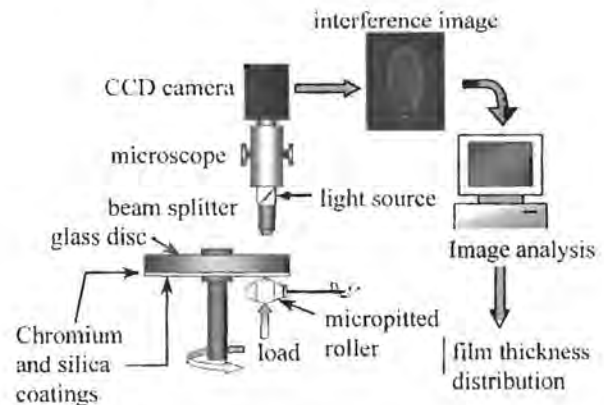
Fig. 5. Schematic of SLIM technique [13].

Optical interference images were obtained using the “Spacer Layer Imaging Method” (SLIM) which has been described earlier [11,13]. The lubricant used for this part of the work was a polyalphaolefin which had a viscosity of 0.1230 Pa s and a pressure viscosity coefficient of  $24.7 \text{ GPa}^{-1}$  at 40 °C.

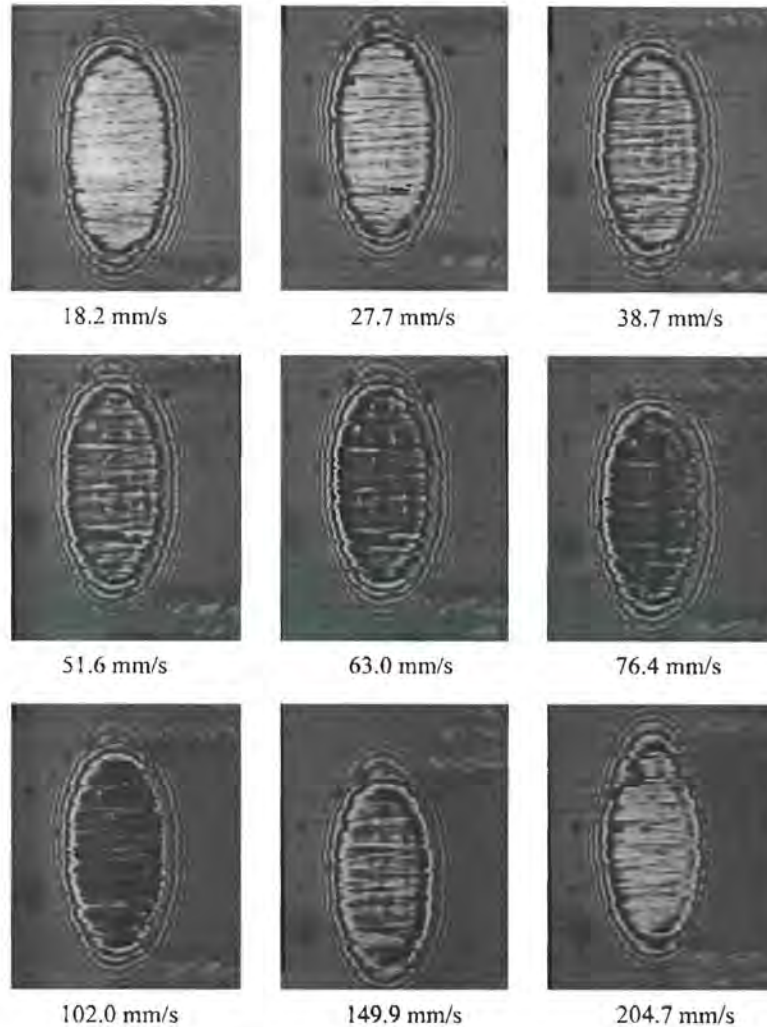
Fig. 6. Interference images of undamaged roller surface for a range of rolling speeds.

Interference images for the undamaged surface are shown in Fig. 6 for a range of entrainment speeds in pure rolling. Fig. 7 shows the mean central film thickness as a function of rolling speed compared with that predicted by the Hamrock and Dowson equation [14]. The film was somewhat thinner than predicted, probably due to the effect of the longitudinal roughness. Changing the slide-roll ratio had a negligible effect on the thickness of the film formed by the undamaged roller.

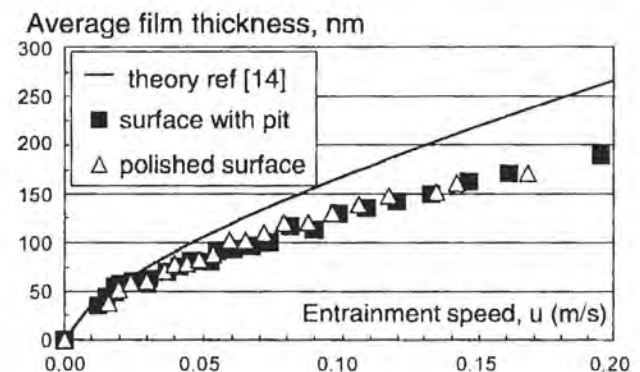
Fig. 7. Comparison of mean film thickness with smooth surface prediction.

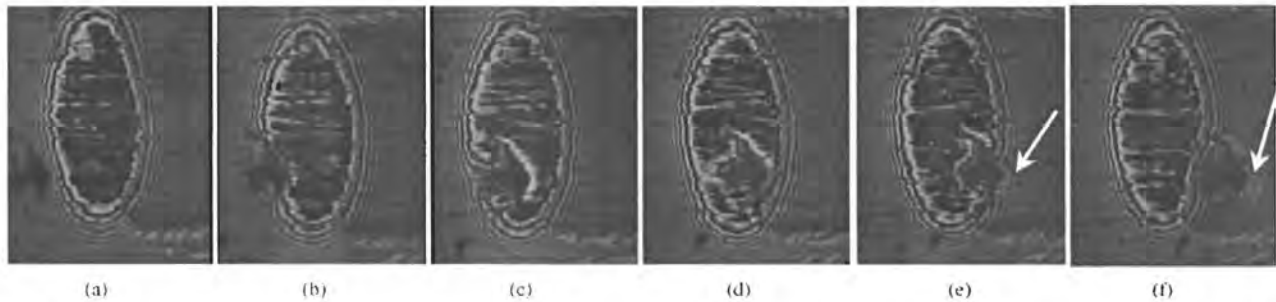
Fig. 8. Sequence of interference images showing micropit passing through contact in pure rolling. Entrainment speed = 100 mm/s. Arrows show fluid expelled into cavitated region.

Fig. 8 shows a sequence of interference images of the micropit passing through the contact in pure rolling with (both) surfaces travelling at 100 mm/s. Two features associated with

the pit are apparent. Firstly, there is a region of much thinner film near the leading edge of the pit when near the centre part of the contact (Fig. 8c). (The central part of the pit appears dark on the interference image because there is no reflection

from the underlying fracture surface.) Secondly, when the pit enters the cavitated region at the exit, fluid can be seen escaping (Fig. 8e and f). Away from the immediate vicinity of the pit, the film thickness was unaffected by its presence.

- In contrast, *positive* sliding (pit on faster surface) leads to both the closure of the crack (reducing or removing the leakage path) and to the obscuring of any residual starvation by the defect itself.
- Finally, upon exit from the contact, fluid is expelled – a process assisted by the higher compressive loading caused by negative sliding (Figs. 8 and 11c).

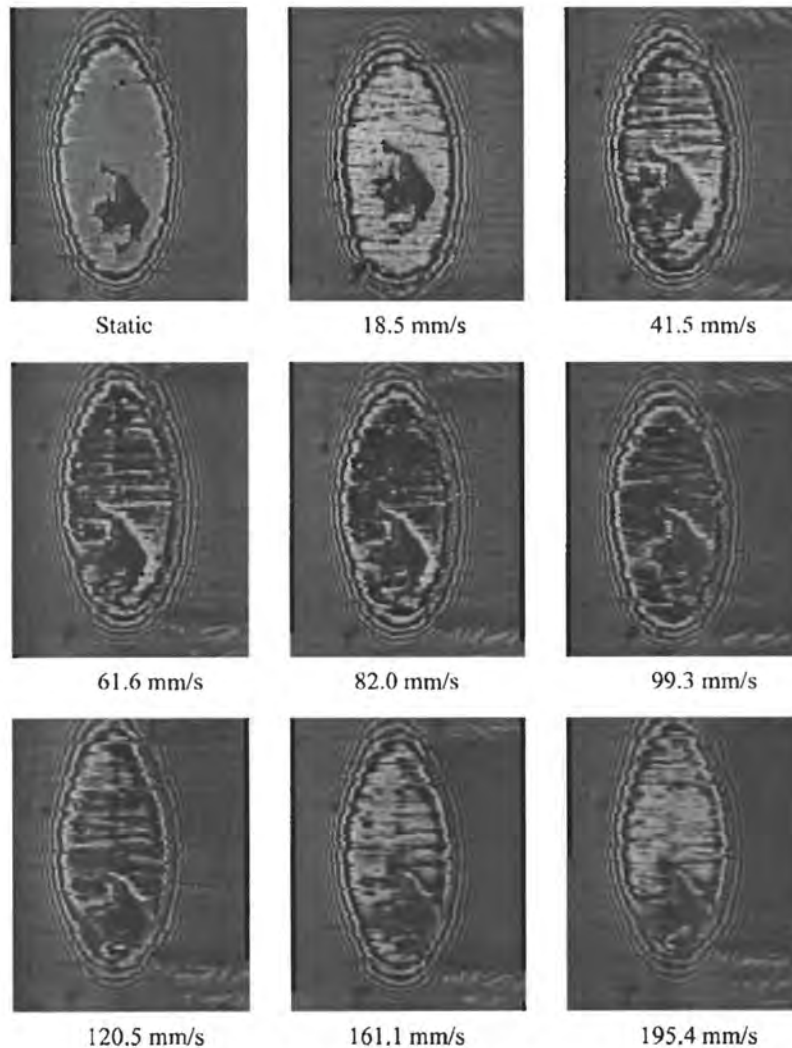
Fig. 9. Interference images showing micropit in contact at different rolling speeds.

Varying the speed in pure rolling had little effect except to increase the thickness of the film remote from the micropit (Fig. 9). Again, the mean film away from the pit was similar to that of the undamaged surface.

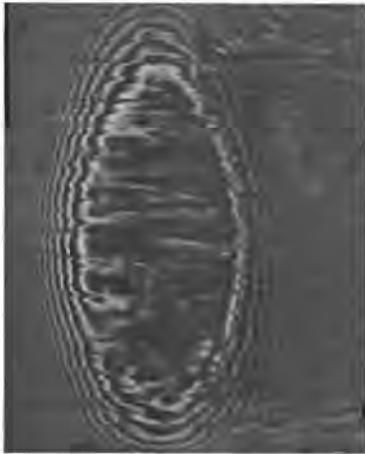
Fig. 10. Interference images showing micropit passing through contact under conditions of positive slide-roll ratio.

Next, the influence of sliding was investigated by altering the rotational speed of the disc and roller. A typical interference image for positive slide roll ratio (speed of disc surface = 49 mm/s, speed of micropitted roller surface = 149 mm/s) is shown in Fig. 10. It is similar to the pure rolling result except that the constriction near the leading edge of the pit appears somewhat less prominent.

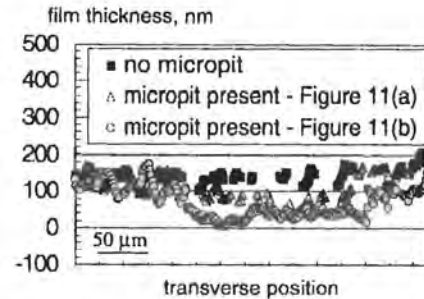
Fig. 12. Film thickness along a transverse line just ahead of the micropit under conditions of negative slide-roll ratio.

The actual film thickness along a transverse line in the thinner region just ahead of the pit is shown in Fig. 12. (The location of this line is shown in Fig. 11b and c.) This shows a film thickness of around 40 nm and is less than 10 nm in some areas, compared to around 130 nm remote from the pit.

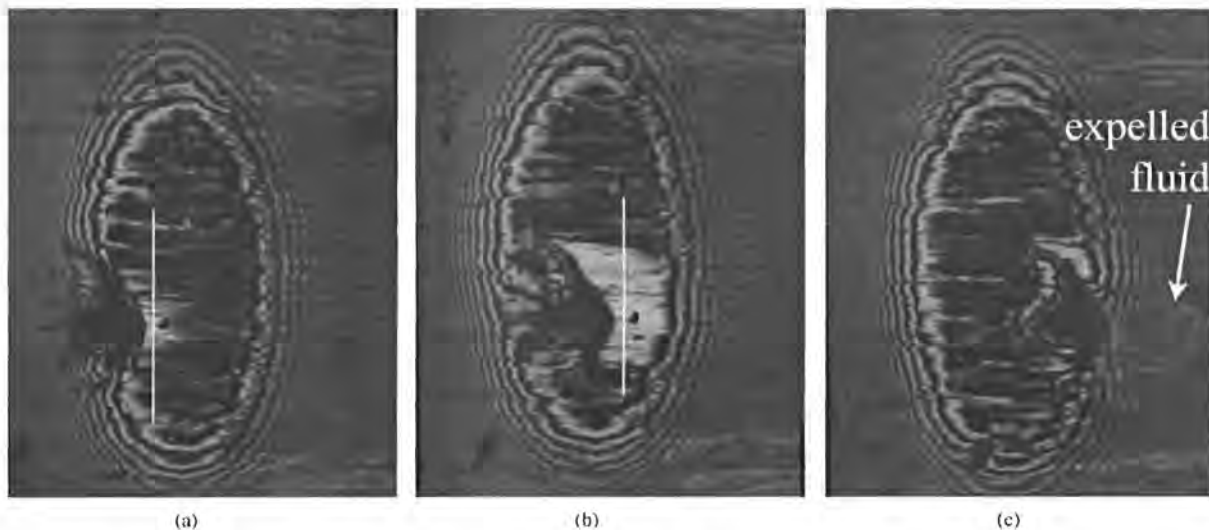
Fig. 11. Sequence of interference images showing micropit passing through contact under conditions of negative slide-roll ratio. The vertical lines in (a) and (b) show the regions analysed in Fig. 12. Note large amount of fluid expelled into cavitated region in (c)—compare with Fig. 8e and f.

The corresponding condition with *negative* slide roll ratio (speed of disc surface = 149 mm/s, speed of micropitted roller surface = 49 mm/s) is illustrated in Fig. 11, which shows a sequence of three images as the micropit passes through the contact. Here, the leading edge constriction is much more prominent and at one point extends about

100  $\mu\text{m}$  from the pit right across the contact to the exit (Fig. 11b).

In addition, the expulsion of fluid in the cavitated region is much more marked than in the corresponding pure rolling or positive slide roll ratio conditions (Fig. 11c).

ing its approach to the contact region. Since it contains a deep and extensive leakage path, the micropit reduces the local pressure to a low value as it passes into the inlet region. This causes a reduction in local film thickness, akin to transient starvation, which "convects" toward the exit at a speed greater than that of the pit, leading to the band of low film thickness seen in Fig. 11b and c.
