11FTM18

AGMA Technical Paper

Longitudinal Tooth Contact Pattern Shift

John B. Amendola, John B. Amendola III, and Dereck Yatzook, Artec Machine Systems

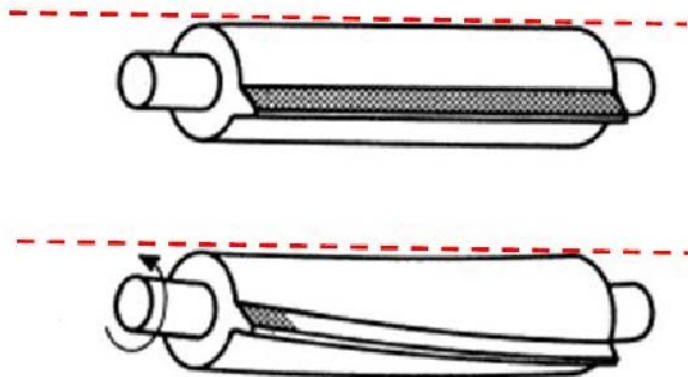
Every gearset is subject to torque, resulting in elastic deflection of the gear tooth parts as well as the entire rotor body. Individual teeth bend, the pinion and wheel bodies twist, bend, and expand under the effect of the torque, load, and centrifugal forces; see Figure 1.

Figure 1. Tooth contact patterns of a spur toothed pinion without longitudinal correction at rest (top) and with load with load (bottom) applied

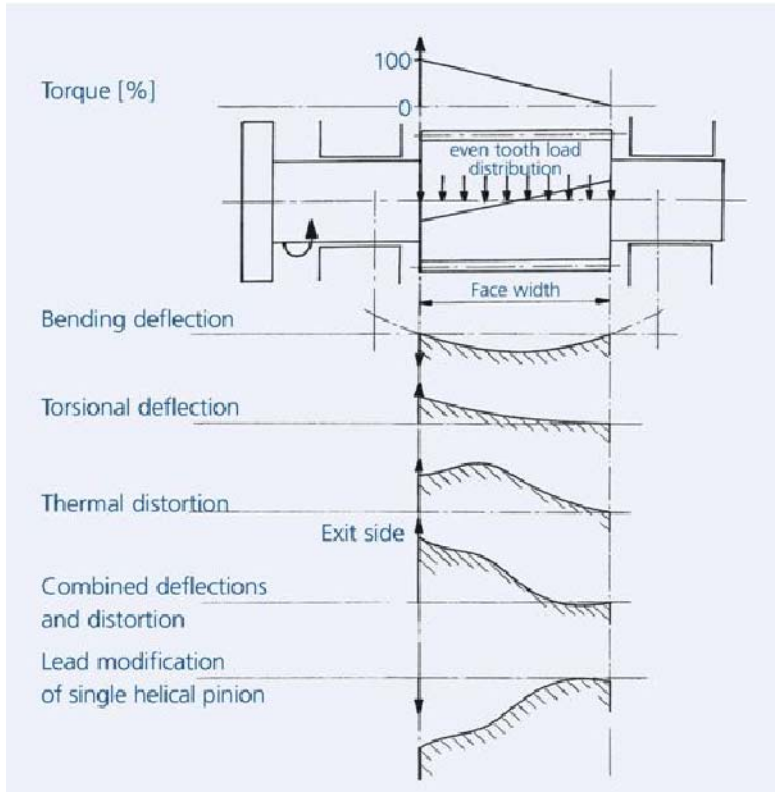
Tooth modification for gear sets with pitch line velocities greater than 100 m/s require careful consideration of thermal distortion. The resulting thermal deformation, in addition to the mechanical deflections, requires a composite profile and longitudinal modification to achieve proper load distribution under operating conditions; see Figure 2 and Figure 3.

Figure 2. Schematic of single helical tothing deflection with added parameter for thermal deformation and the associated lead correction

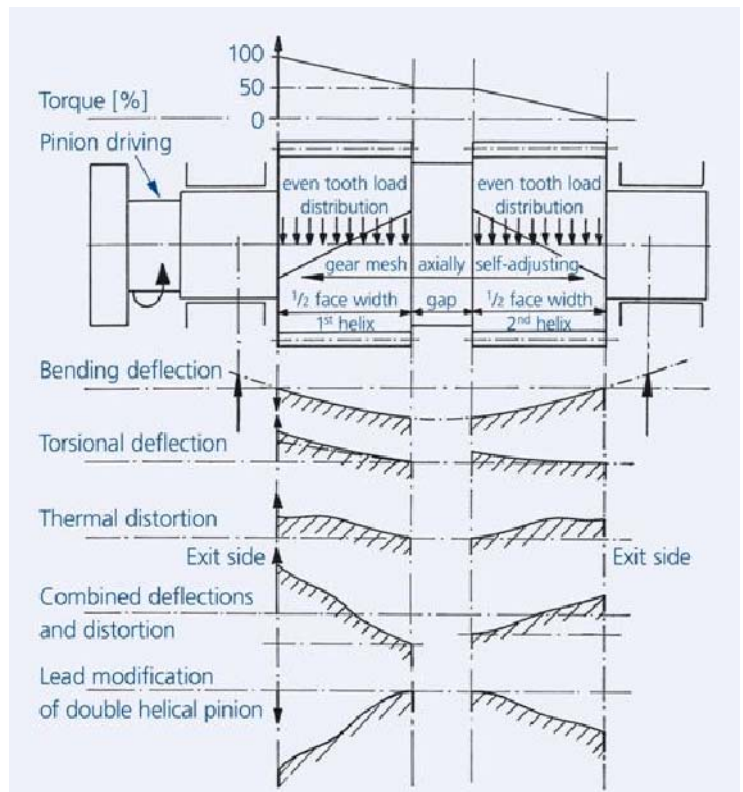
Figure 3. Schematic of double helical tothing deflection with added parameter for thermal deformation and the associated lead correction

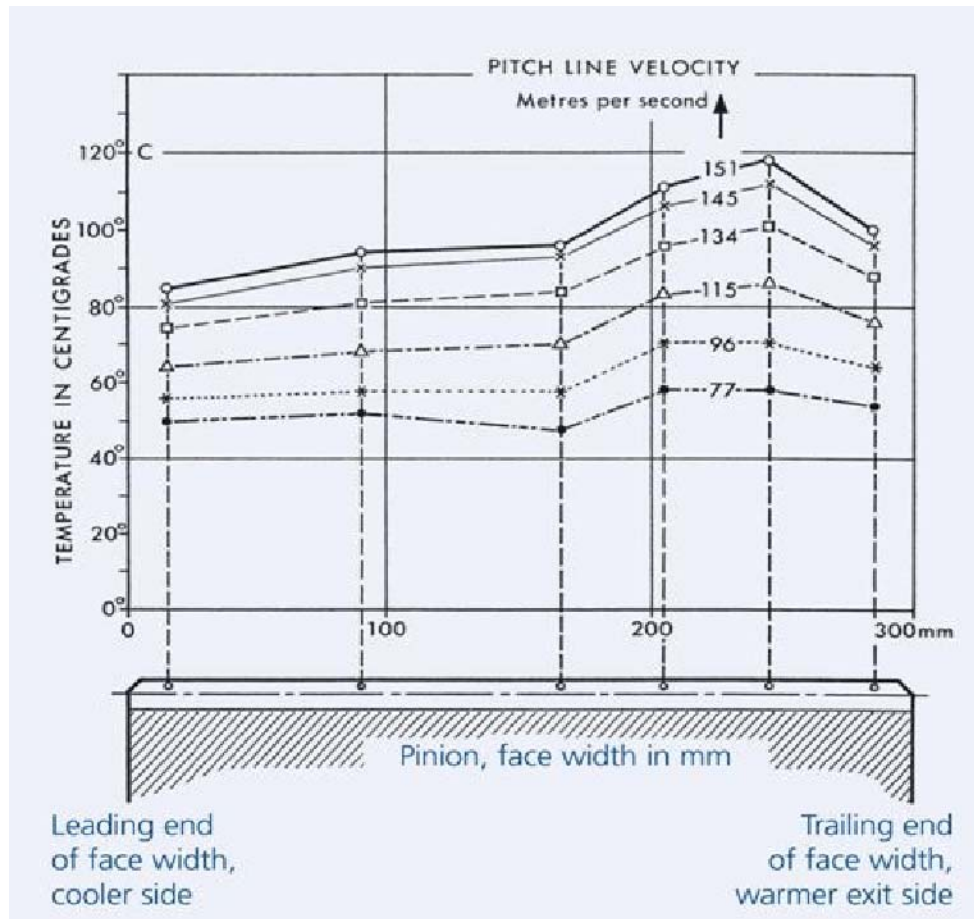
Investigations by Martinaglia were performed to accurately determine temperature conditions in a high speed pinion, see Figure 4.

Figure 4. Effect of pitch line velocity on tooth flank temperature, establishment of an asymmetrical speed/temperature gradient

During gear unit operation there is a high velocity axial flow of lube, oil and air across the helix(s) of the mesh. Through mesh engagement, oil and air are mixed and compressed resulting in an asymmetrical (uneven) tooth flank temperature gradient; see Figure 4.
